## **Appendix D - Comments Received During Public Comment Period and Management Team Response to Comments**

Thirteen comments on the Draft Final Report for the Cook Inlet Risk Assessment were received from the following individuals and organizations. Comments are included in this Appendix in the order in which they were received, followed by a response to comments developed by the Management Team.

## PEER REVIEW

Project 0268205;RS-PR-14-117-001 Rev2

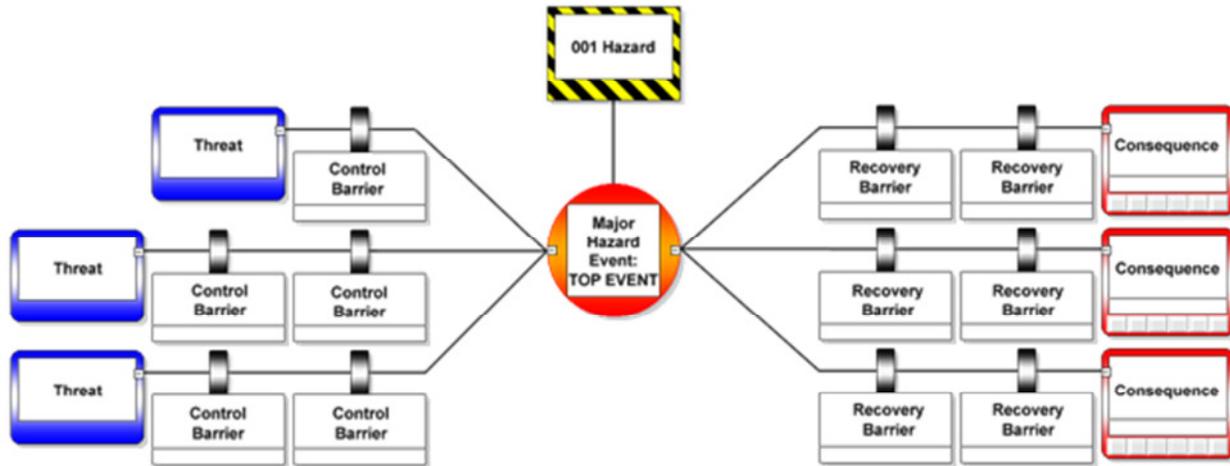
Figure 3.1: Example Bowtie Diagram

BTD are now widely accepted as being a highly effective means of illustrating the causes, outcomes and preventative/mitigative controls associated with major accident events. The CIRA report would have benefited from presenting the characteristics of the oil spill events in this manner.

A stylized BTM is illustrated in Figure 3.1
